Editorial

Framing Background

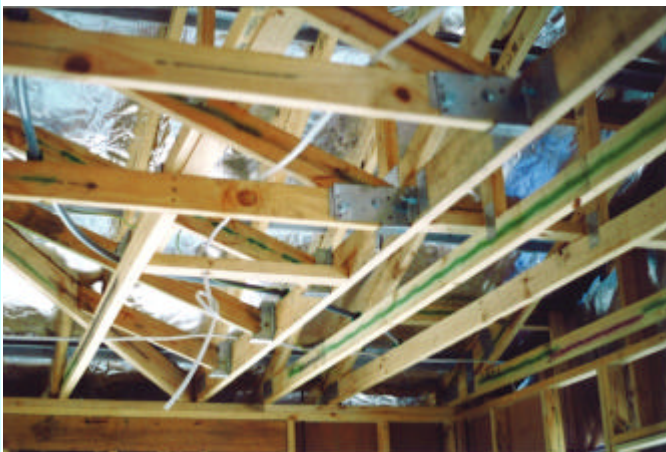
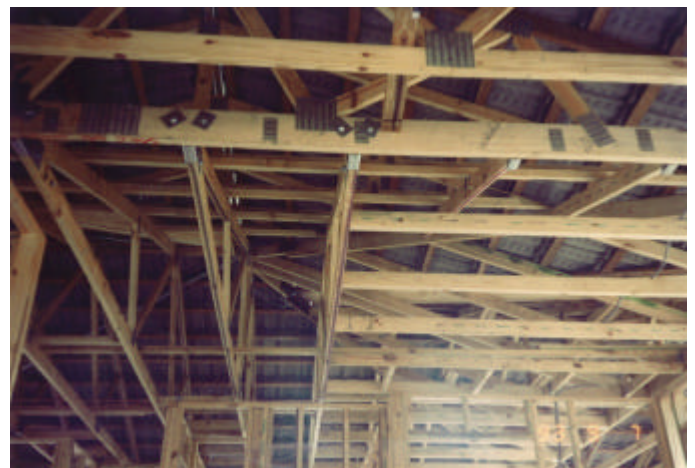
When a trussed roof changes direction it does so at a girder truss. They are load bearing trusses and are usually designed with a negative camber arching upwards possibly 5 to 10mm. Far from a level substrate when you consider trusses abutting the girder truss sometimes have no camber and fit into a metal bracket that normally sits below the girder truss.

Consider also that the truss manufacturer relies on the plasterboard for bottom chord bracing and you begin to realise we still have a long way to go with maintenance reduction.
